NORTON RESERVOIR DAM

MA 00815

PHASE I INSPECTION REPORT
NATIONAL DAM INSPECTION PROGRAM

AUGUST 1978

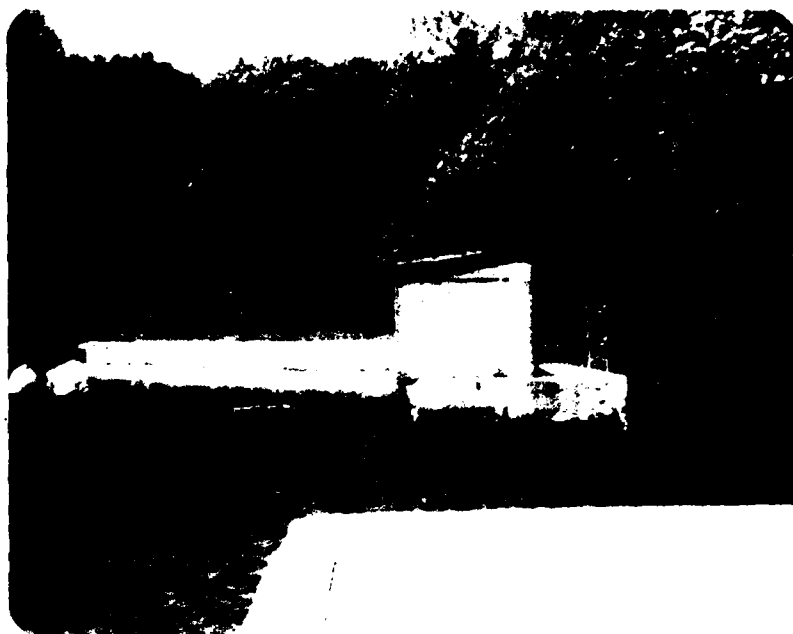
8

Left Abutment Looking Across Spillway

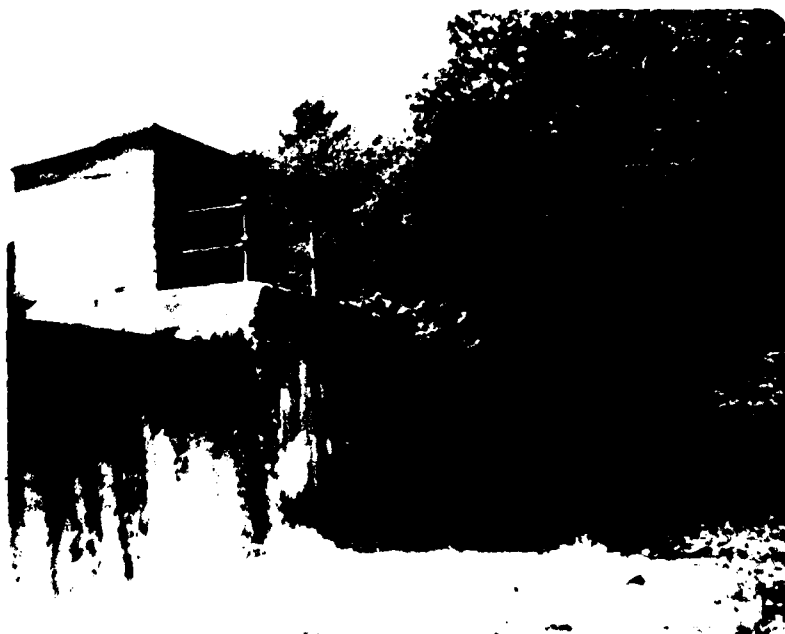
9

Left Abutment Looking Across Apron

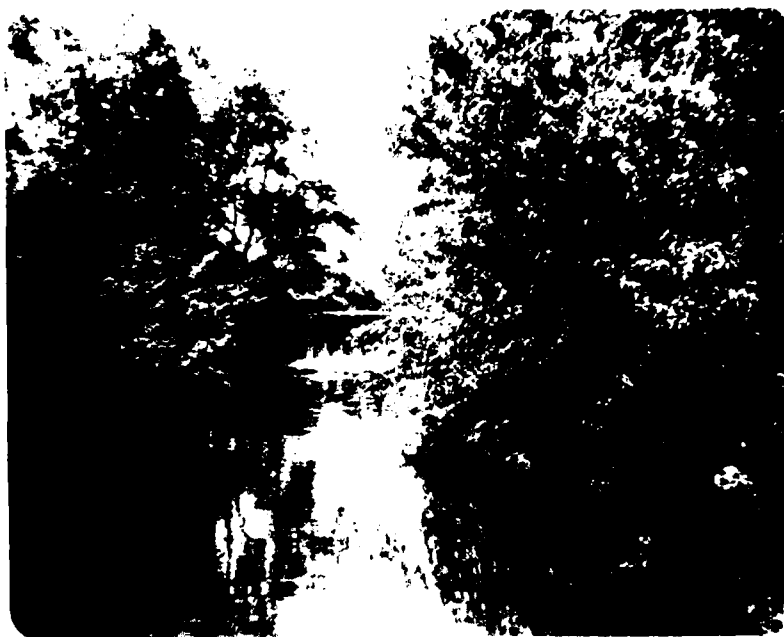
Downstream View of Dam
